MERCEDES-BENZ

MB100 - MB100D - MB120 - MB140 - MB160 - MB180

**512.810**  
**512.809**

Choc avant sur calase  
Front crash on the car-body  
Frontreparatur an Karosserie  
Urto anteriore sulla scocca  
Choque delantero sobre caja

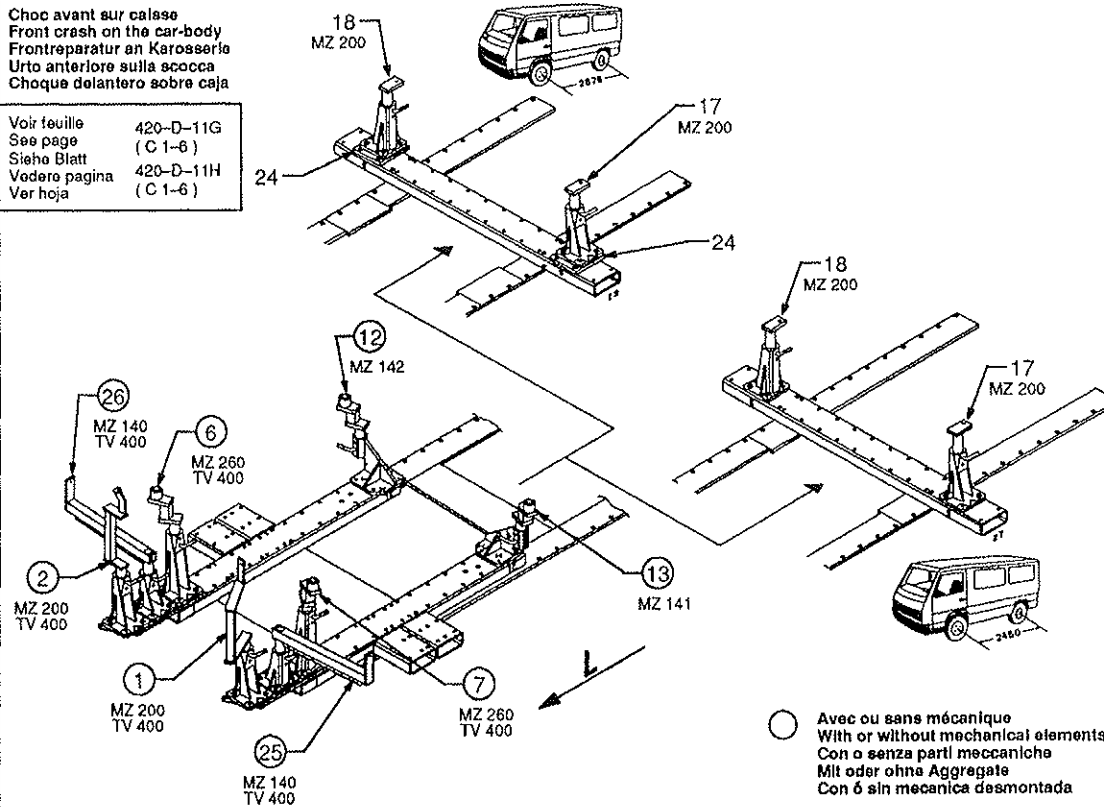
Voir feuille 420-D-11G  
See page (C 1-6)  
Siehe Blatt  
Vedere pagina 420-D-11H  
Ver hoja (C 1-6)

○ Avec ou sans mécanique  
With or without mechanical elements  
Con o senza parti meccaniche  
Mit oder ohne Aggregate  
Con ó sin mecánica desmontada

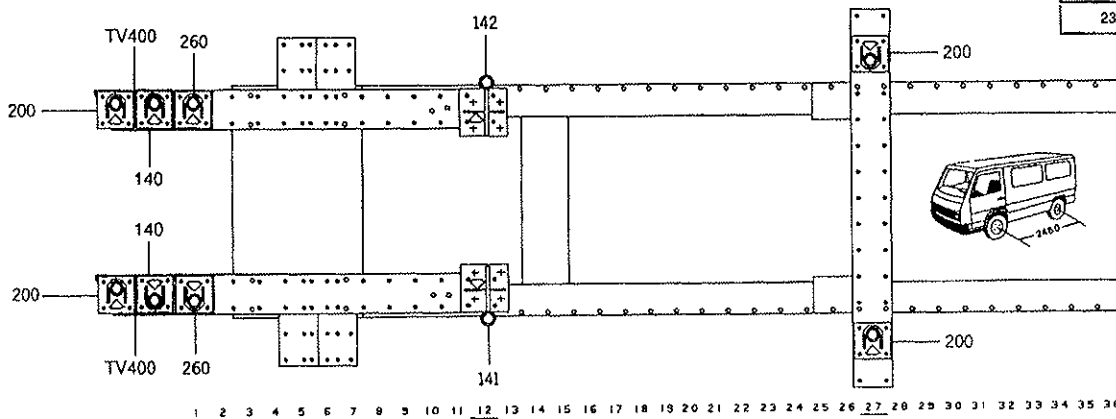
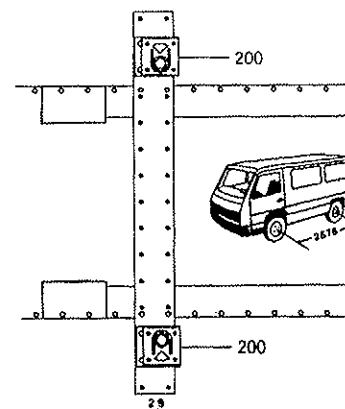
| 230 Kg | 29.01.90 420-D-11 i |

Choc arrière sur caisse  
Rear crash on car-body  
Heckreparatur an Karosserie  
Urto posteriore sulla scocca  
Choque trasero sobre caja

Voir feuille 420-D-11G  
See page (C 1-6)  
Siehe Blatt 420-D-11H  
Vedere pagina (C 1-6)  
Ver hoja

○ Avec ou sans mécanique  
With or without mechanical elements  
Con o senza parti meccaniche  
Mit oder ohne Aggregate  
Con ó sin mecánica desmontada

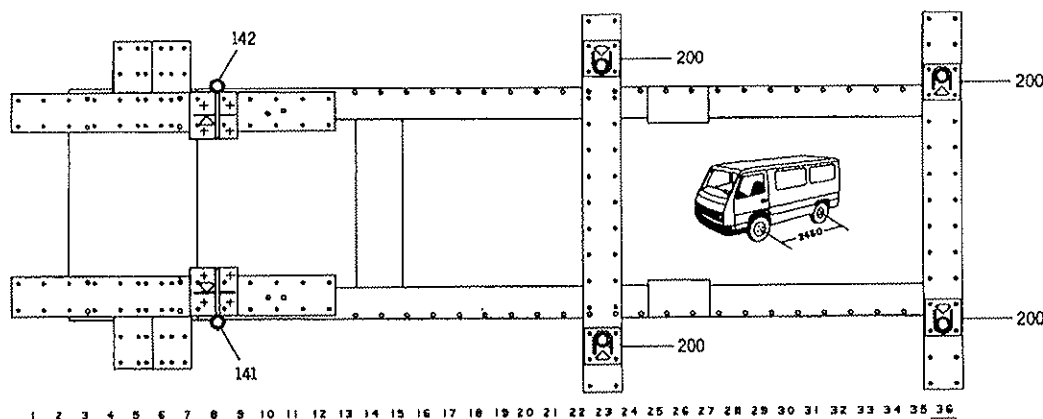
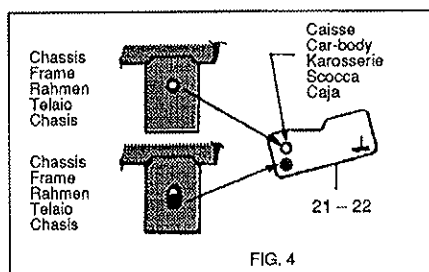
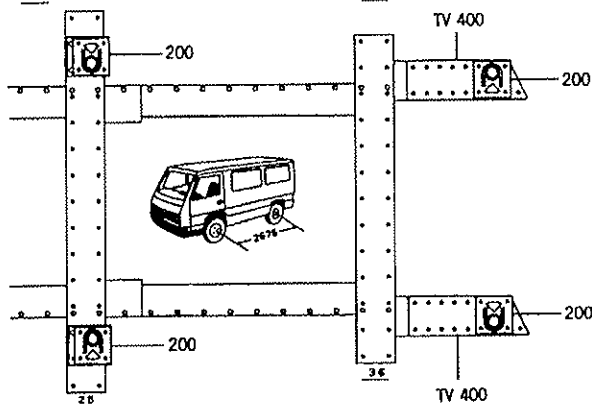
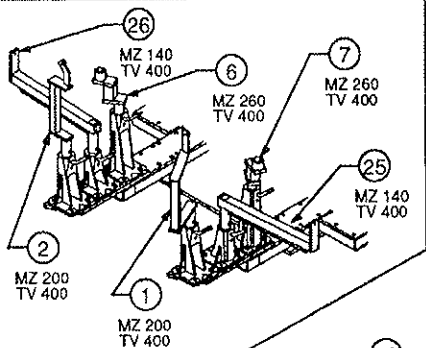
230 Kg 29.01.90 420-D-11 J

Choc avant sur chassis ou chassis plus caisse  
Front crash on the frame or frame + car-body  
Frontreparatur am Rahmen oder am kompletten Fahrzeug  
Urto anteriore sul telaio + scocca  
Choque delantero sobre chasis o chasis + caja

Voir feuille 420-D-11G  
See page (A 1-9 oder D 1-7)  
Siehe Blatt 420-D-11H  
Vedere pagina (A 1-8 oder D 1-6)  
Ver hoja

○ Avec ou sans mécanique  
With or without mechanical elements  
Con o senza parti meccaniche  
Mit oder ohne Aggregate  
Con ó sin mecanica desmontada

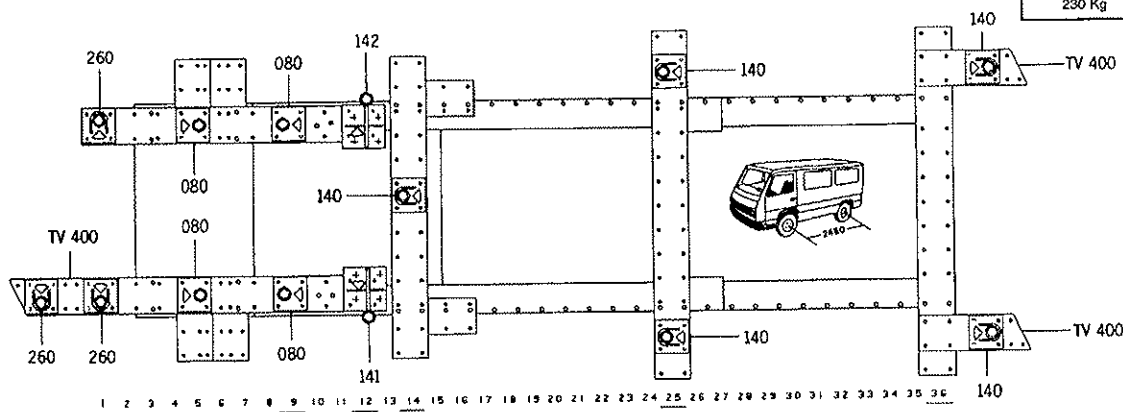
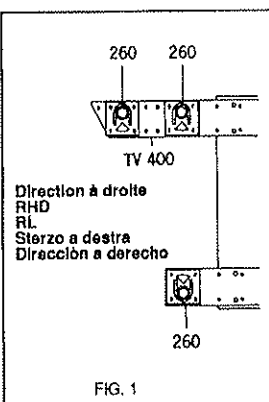
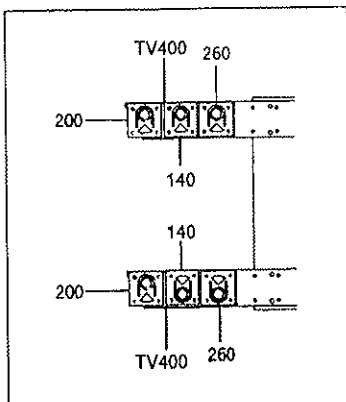
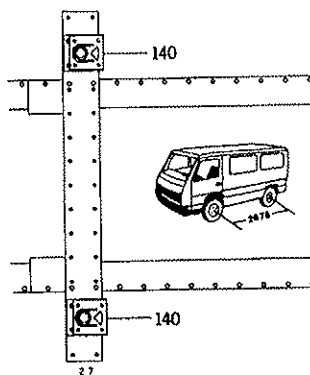
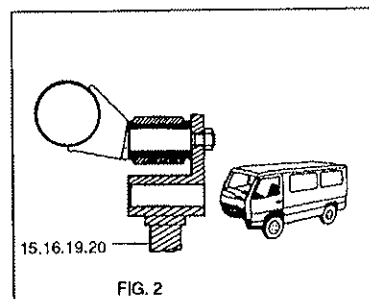
| 230 Kg 29.01.90 420-D-11 K |

A partir du N° de châssis ....57303.  
Ab chassis N° ....57303.

Choc avant sur châssis ou châssis plus caisse  
Front crash on the frame or frame + car-body  
Frontreparatur am Rahmen oder am kompletten Fahrzeug  
Urto anterloro sul telaio + scocca  
Choque delantero sobre chasis o chasis + caja

Voir feuille 420-D-11G  
See page (A 1-9 oder D 1-7)  
Siehe Blatt 420-D-11H  
Vedere pagina (A 1-8 oder D 1-6)  
Ver hoja

○ Avec ou sans mécanique  
With or without mechanical elements  
Con o senza parti meccaniche  
Mit oder ohne Aggregate  
Con ó sin mecánica desmontada

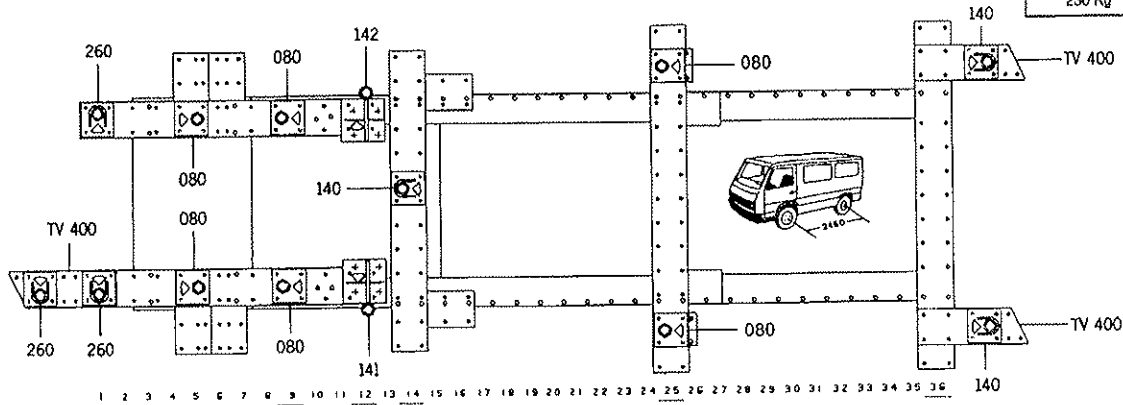
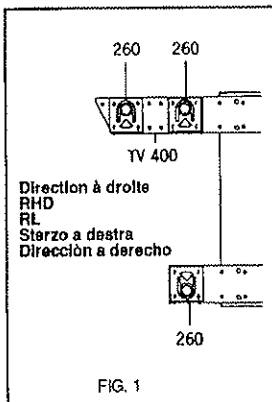
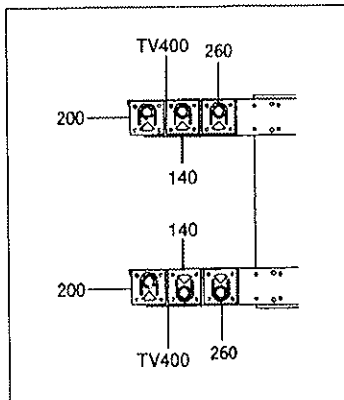
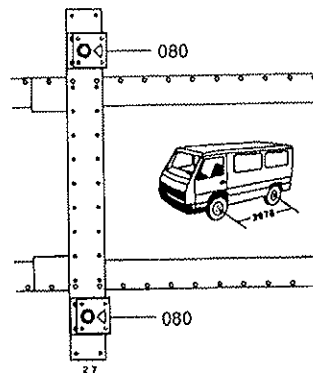
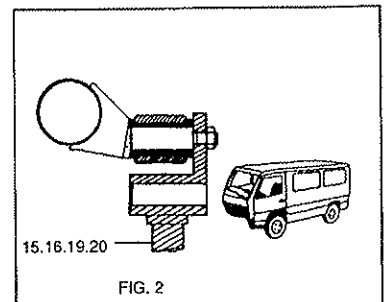
230 Kg 29.01.90 420-D-11 L

Léger choc arrière avec mécanique arrière  
 Light rear crash with rear mechanical units in place  
 Leichter Heckshaden bei eingebaute Aggregate (hinten)  
 Urto posteriore leggero con meccanica posteriore  
 Legero choque trasero con mecanica trasera montada

Voir feuille  
 See page  
 Siehe Blatt  
 Vedere pagina  
 Ver hoja

○ Avec ou sans mécanique  
 With or without mechanical elements  
 Con o senza parti meccaniche  
 Mit oder ohne Aggregate  
 Con ó sin mecanica desmontada

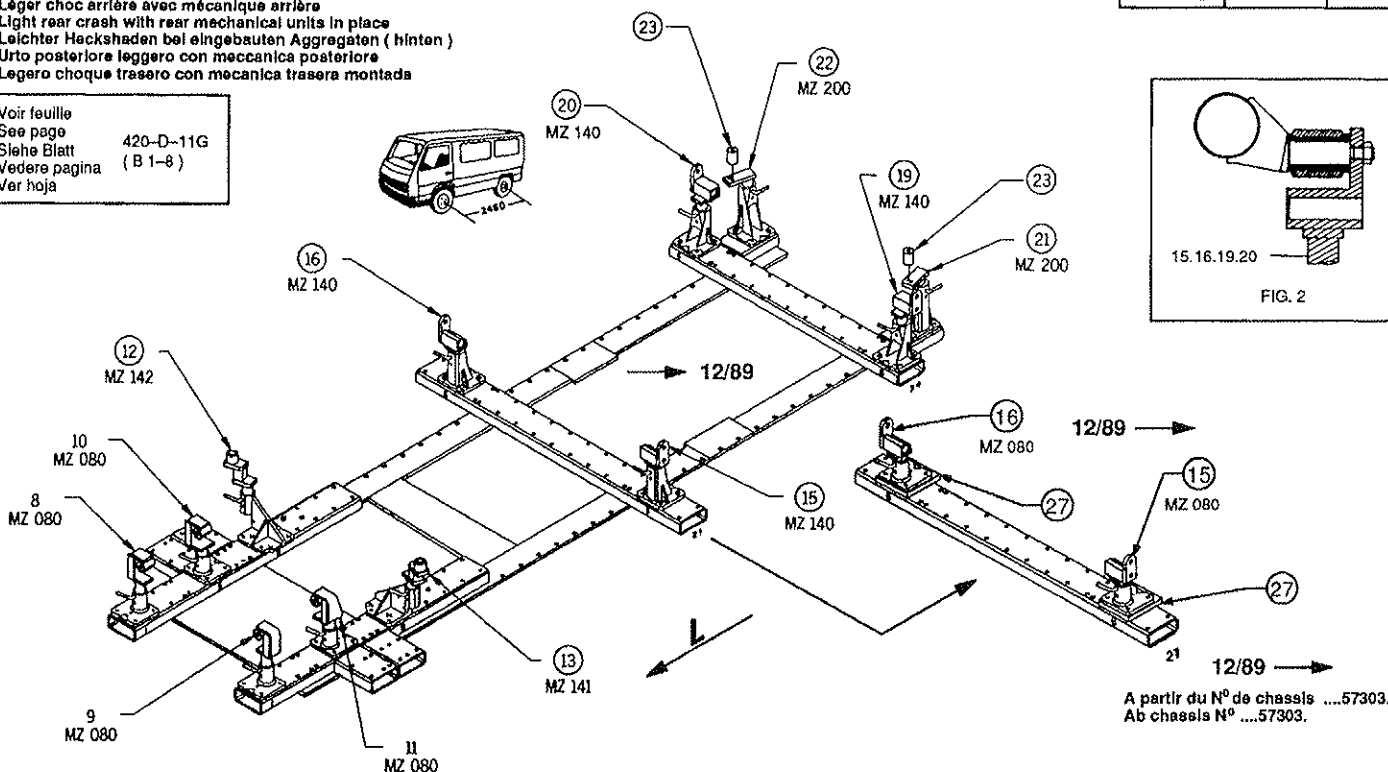
Léger choc arrière avec mécanique arrière  
 Light rear crash with rear mechanical units in place  
 Leichter Heckshaden bei eingebaute Aggregate (hinten)  
 Urto posteriore leggero con meccanica posteriore  
 Legero choque trasero con mecanica trasera montada

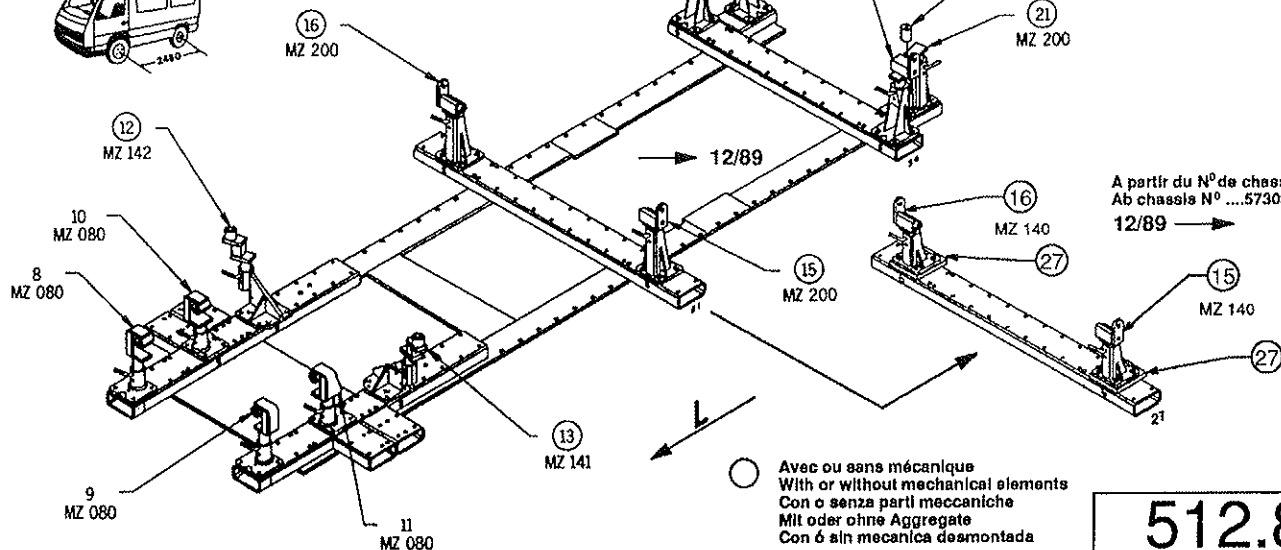
Choc arrière sur châssis ou châssis plus caisse  
 Rear crash on the frame or frame + car-body  
 Heckreparatur am Rahmen oder am Kompletten Fahrzeug  
 Urto posteriore sul telaio o telaio + scocca  
 Choque trasero sobre chasis o chasis + caja

○ Avec ou sans mécanique  
 With or without mechanical elements  
 Con o senza parti meccaniche  
 Mit oder ohne Aggregate  
 Con ó sin mecanica desmontada

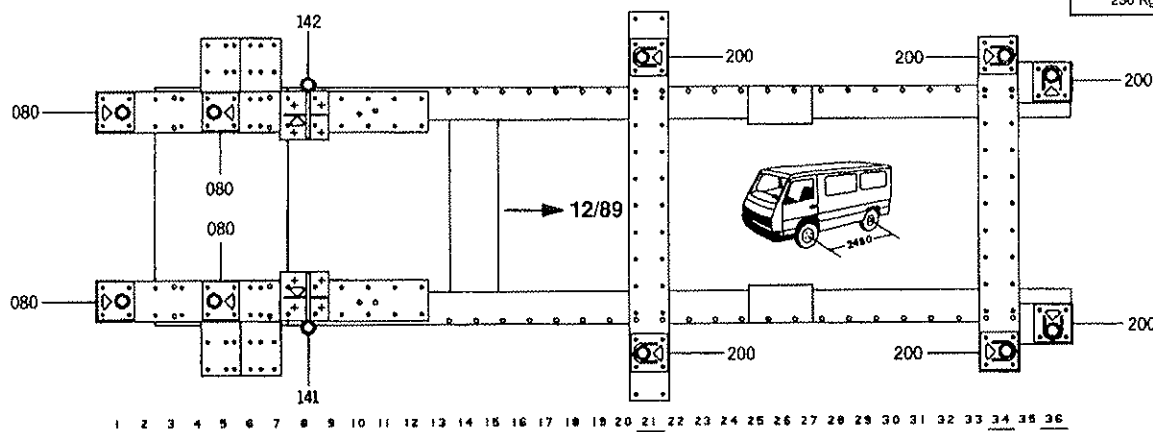
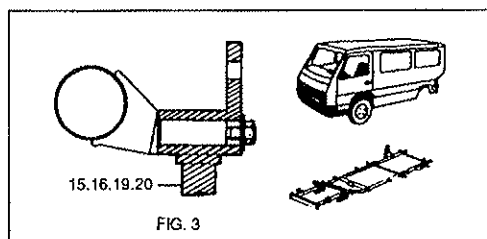
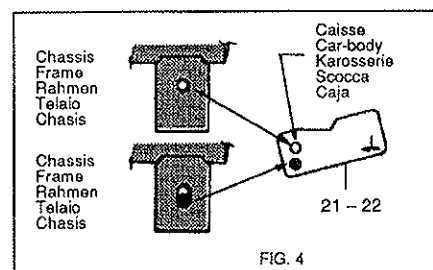
| 230 Kg | 29.01.90 | 420-D-11 N |

Voir feuille  
 See page  
 Siehe Blatt  
 Vedere pagina  
 Ver hoja

A partir du N° de chasis ....57303.  
 Ab chasis N° ....57303.

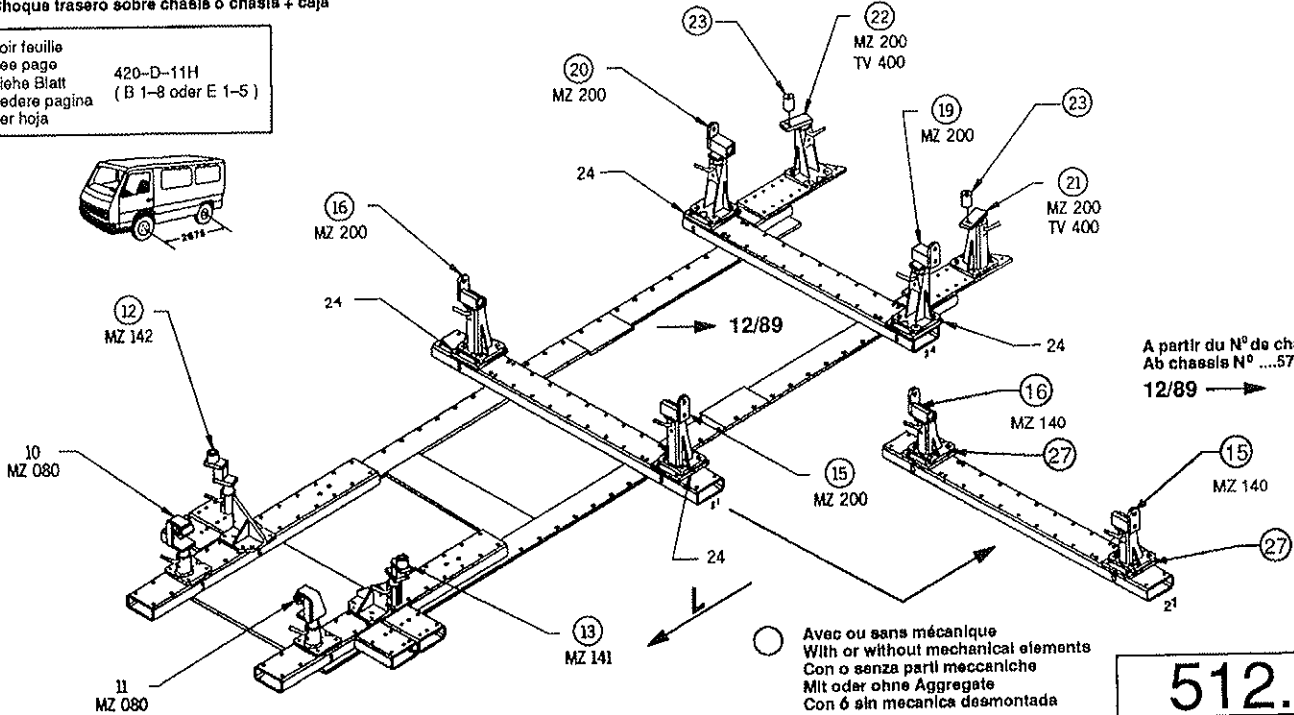
Choc arrière sur châssis ou châssis plus caisse  
 Rear crash on the frame or frame + car-body  
 Heckreparatur am Rahmen oder am Kompletten Fahrzeug  
 Urto posteriore sul telaio o telaio + scocca  
 Choque trasero sobre chasis o chasis + caja

420-D-11H  
 ( B 1-8 oder E 1-5 )

○ Avec ou sans mécanique  
 With or without mechanical elements  
 Con o senza parti meccaniche  
 Mit oder ohne Aggregate  
 Con ó sin mecánica desmontada

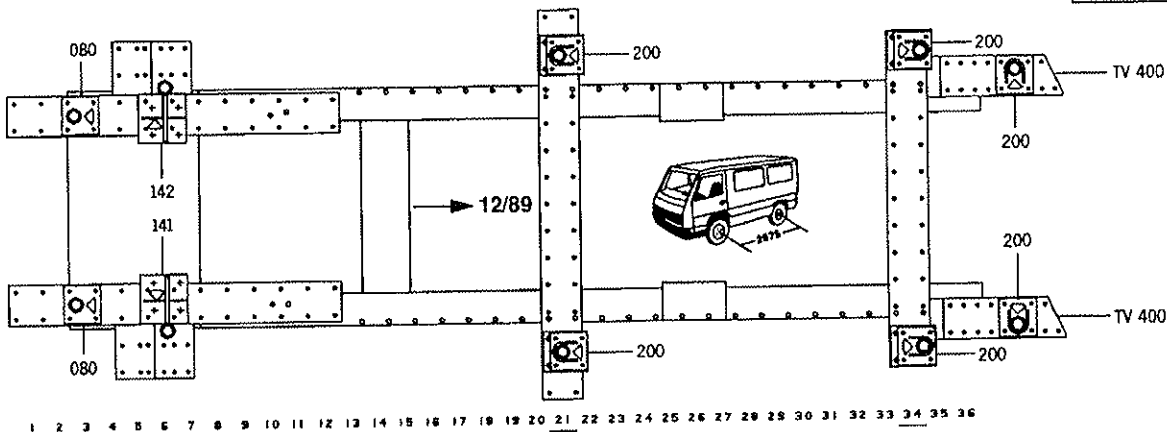
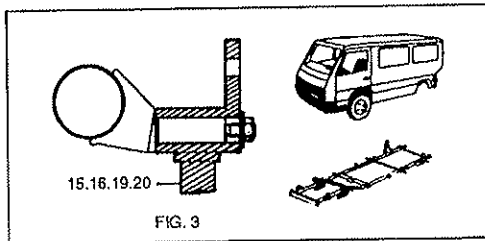
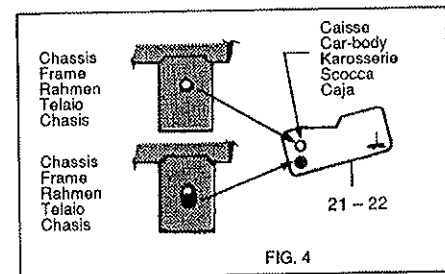
| 230 Kg | 29.01.90 | 420-D-11 ○ |

Voir feuille  
 See page  
 Siehe Blatt  
 Vedere pagina  
 Ver hoja

A partir du N° de chassis ....57303.  
 Ab chassis N° ....57303.  
 12/89 →

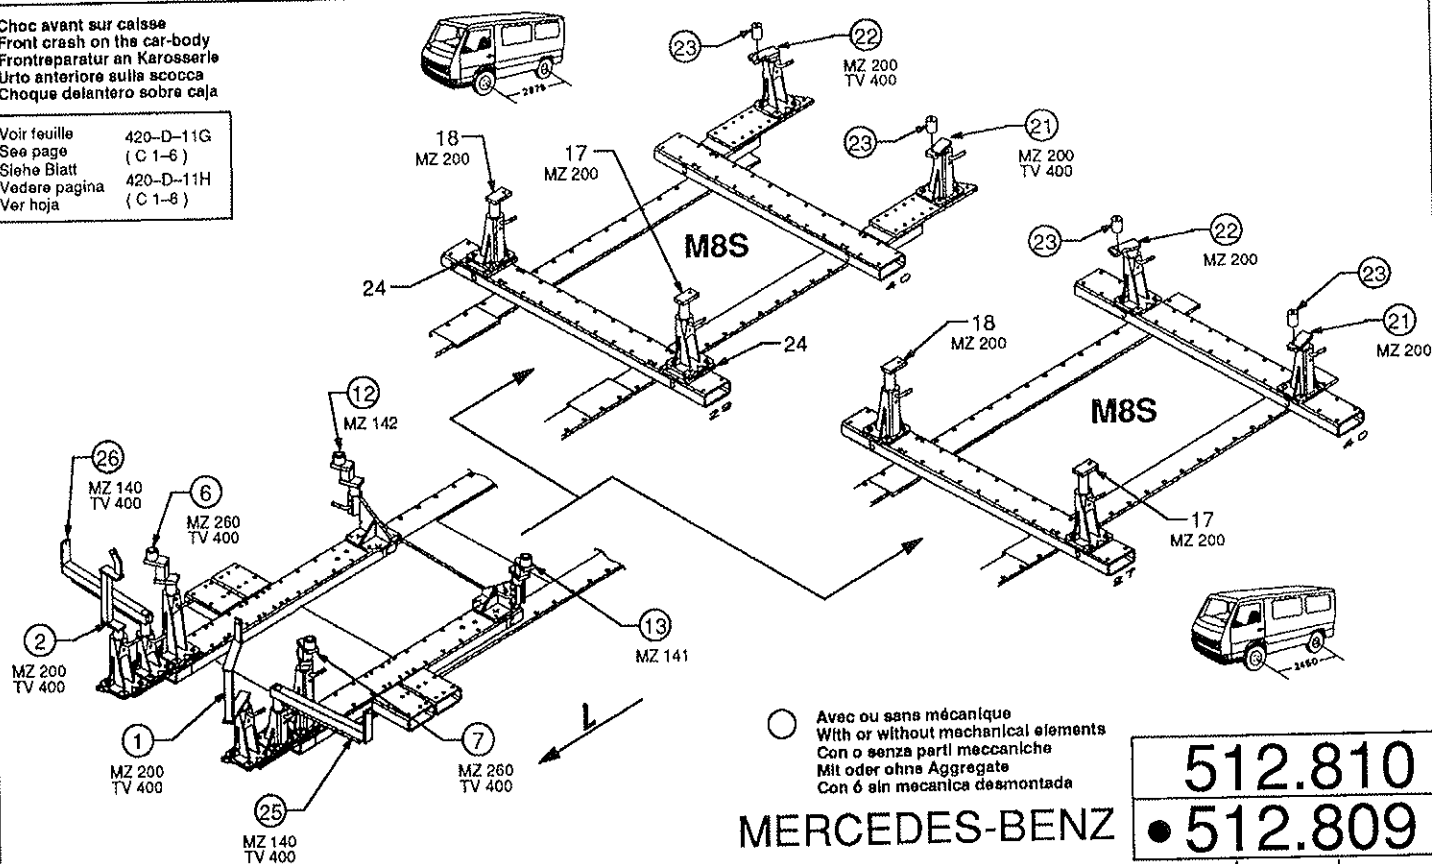
Choc avant sur caisse  
Front crash on the car-body  
Frontreparatur an Karosserie  
Urto anteriore sulla scocca  
Choque delantero sobre caja

Voir feuille 420-D-11G  
See page (C 1-6)  
Siehe Blatt  
Vedere pagina 420-D-11H  
Ver hoja (C 1-8)

○ Avec ou sans mécanique  
With or without mechanical elements  
Con o senza parti meccaniche  
Mit oder ohne Aggregate  
Con ó sin mecánica desmontada

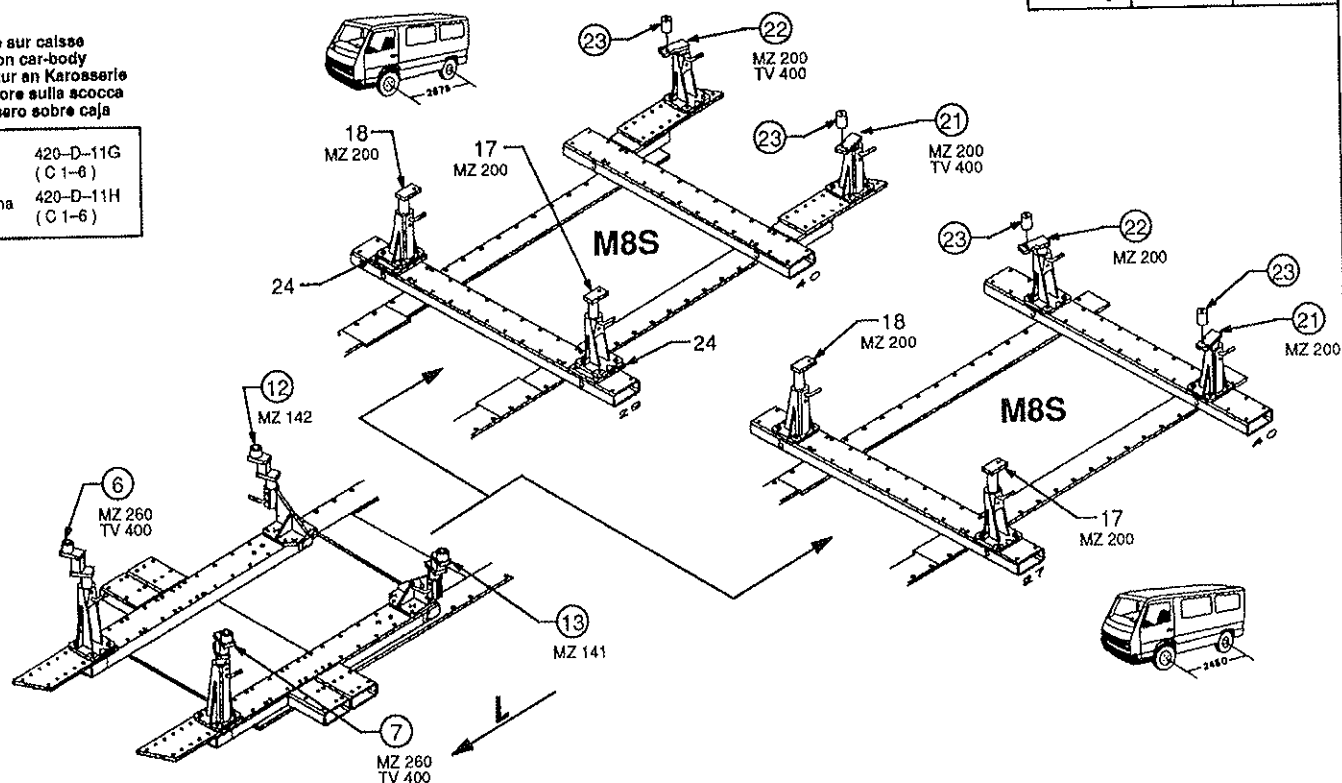
Choc arrière sur caisse  
Rear crash on car-body  
Heckreparatur an Karosserie  
Urto posteriore sulla scocca  
Choque trasero sobre caja

Voir feuille 420-D-11G  
See page (C 1-6)  
Siehe Blatt  
Vedere pagina 420-D-11H  
Ver hoja (C 1-6)

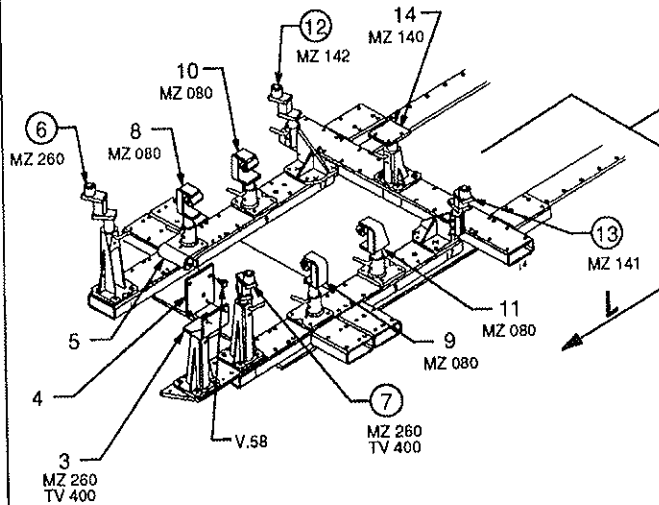
Choc avant sur chassis ou chassis plus caisse  
Front crash on the frame or frame + car-body  
Frontreparatur am Rahmen oder am kompletten Fahrzeug  
Urto enteribre sul telaio + scocca  
Choque delantero sobre chasis o chasis + caja

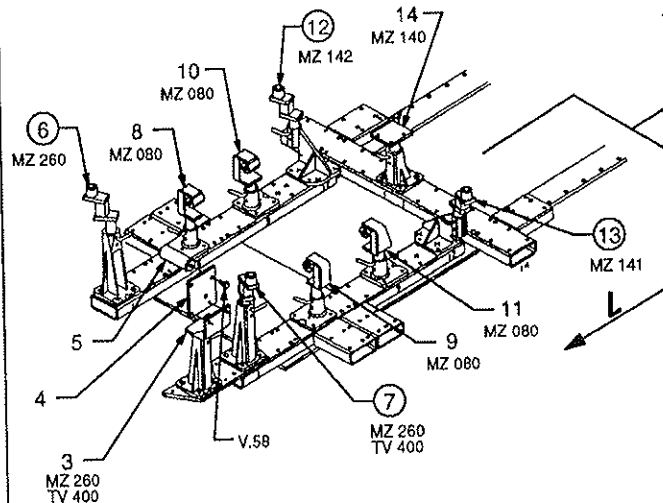
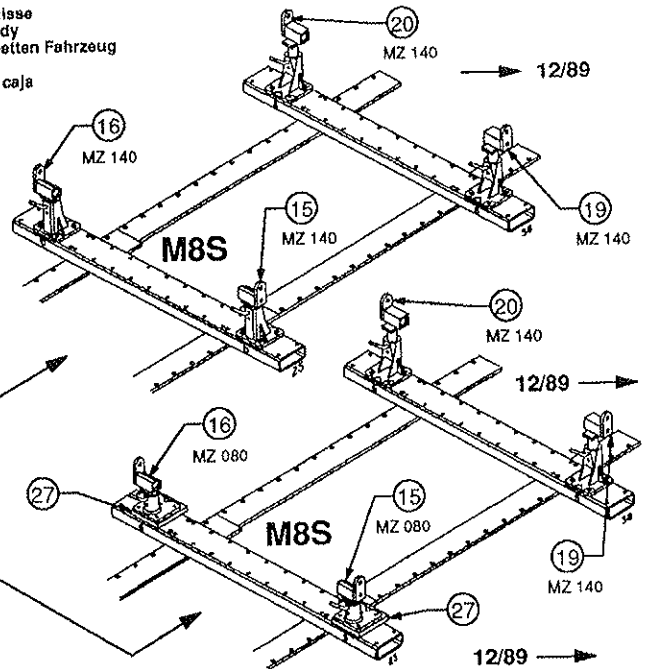
Choc avant sur chassis ou chassis plus caisse  
Front crash on the frame or frame + car-body  
Frontreparatur am Rahmen oder am kompletten Fahrzeug  
Urto enteribre sul telaio + scocca  
Choque delantero sobre chasis o chasis + caja

○ Avec ou sans mécanique  
With or without mechanical elements  
Con o senza parti meccaniche  
Mit oder ohne Aggregate  
Con ó sin mecánica desmontada

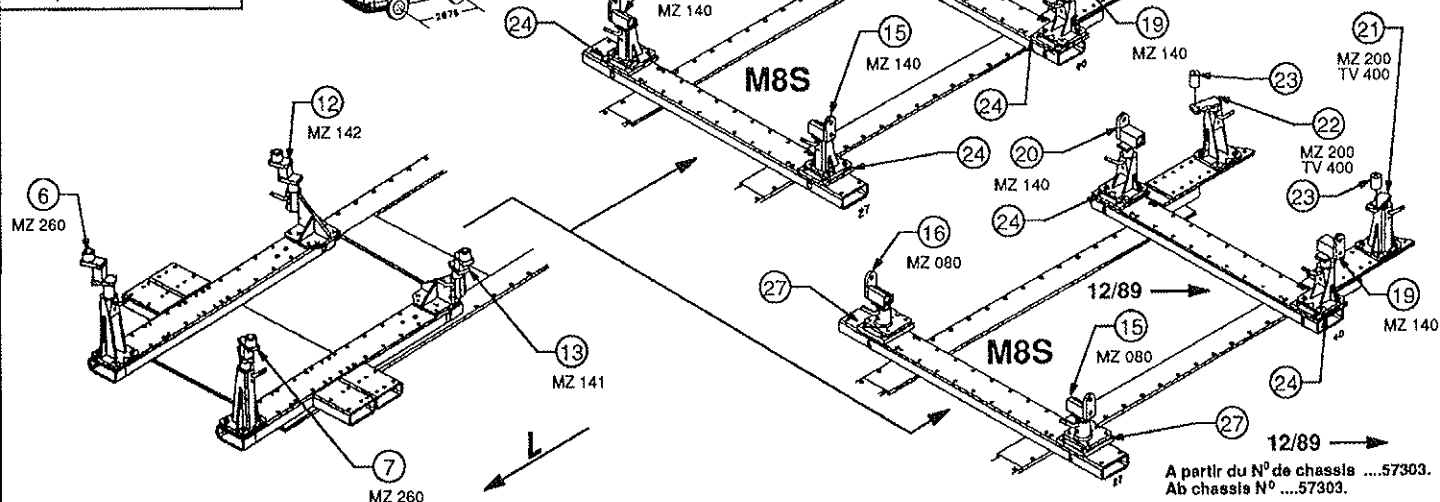
420-D-11H  
(B 1-8)

Léger choc arrière avec mécanique arrière  
Light rear crash with rear mechanical units in place  
Leichter Heckshaden bei eingebauten Aggregaten (hinten)  
Urto posteriore leggero con meccanica posteriore  
Legero choque trasero con mecanica trasera montada

○ Avec ou sans mécanique  
With or without mechanical elements  
Con o senza parti meccaniche  
Mit oder ohne Aggregate  
Con ó sin mecanica desmontada

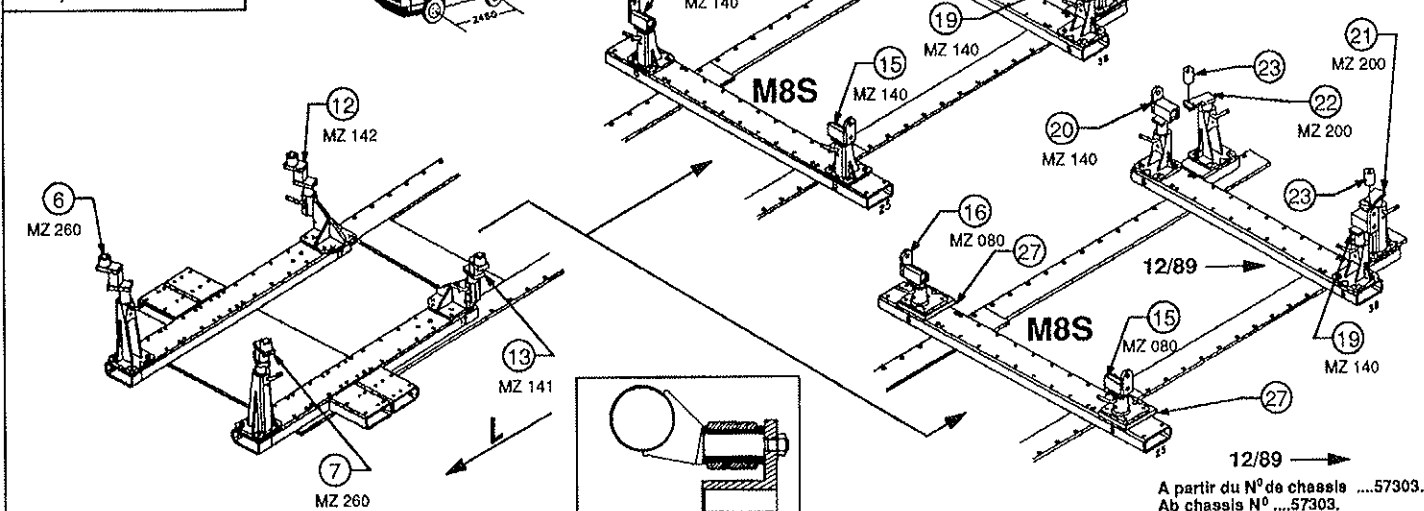
420-D-11G  
(B 1-8)

Léger choc arrière avec mécanique arrière  
Light rear crash with rear mechanical units in place  
Leichter Heckshaden bei eingebauten Aggregaten (hinten)  
Urto posteriore leggero con meccanica posteriore  
Legero choque trasero con mecanica trasera montada

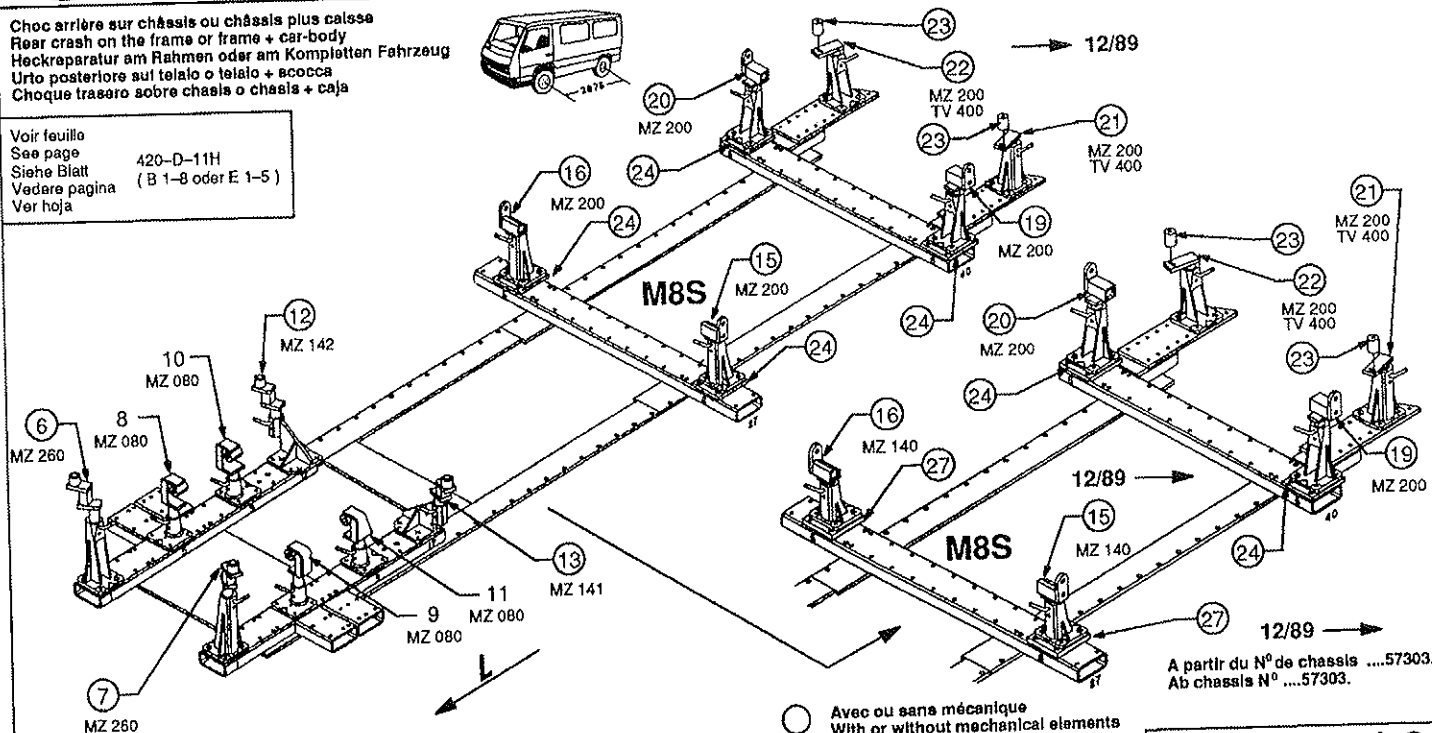
Choc arrière sur châssis ou châssis plus caisse  
Rear crash on the frame or frame + car-body  
Heckreparatur am Rahmen oder am kompletten Fahrzeug  
Urto posteriore sul telaio o telaio + scocca  
Choque trasero sobre chasis o chasis + caja

Voir feuille  
See page  
Siehe Blatt  
Vedere pagina  
Ver hoja  
420-D-11H  
(B 1-8 oder E 1-5)

○ Avec ou sans mécanique  
With or without mechanical elements  
Con o senza parti meccaniche  
Mit oder ohne Aggregate  
Con ó sin mecánica desmontada

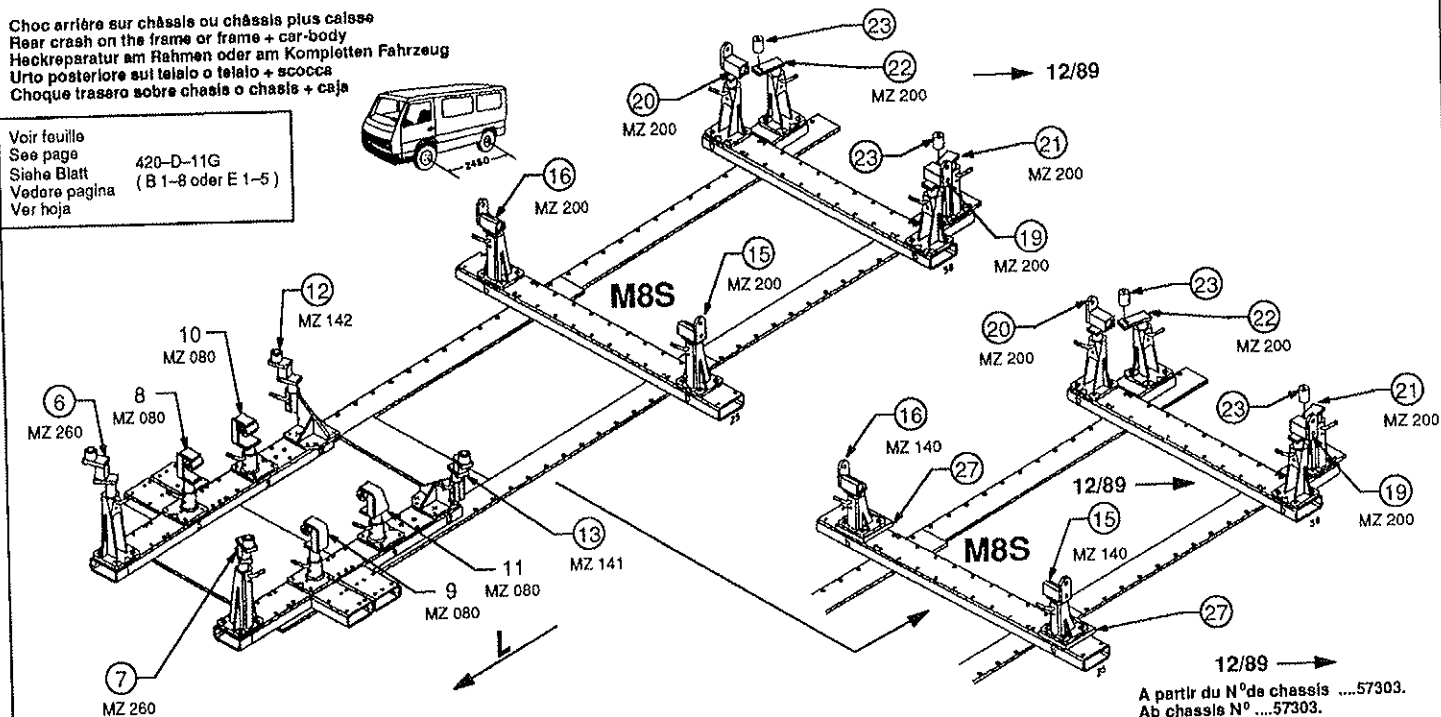
Choc arrière sur châssis ou châssis plus caisse  
Rear crash on the frame or frame + car-body  
Heckreparatur am Rahmen oder am kompletten Fahrzeug  
Urto posteriore sul telaio o telaio + scocca  
Choque trasero sobre chasis o chasis + caja

Voir feuille  
See page  
Siehe Blatt  
Vedere pagina  
Ver hoja  
420-D-11G  
(B 1-8 oder E 1-5)
